# **The Challenge of Orbital Debris**

**Mark Matney, Ph.D.  
Orbital Debris Program Office  
NASA Johnson Space Center**

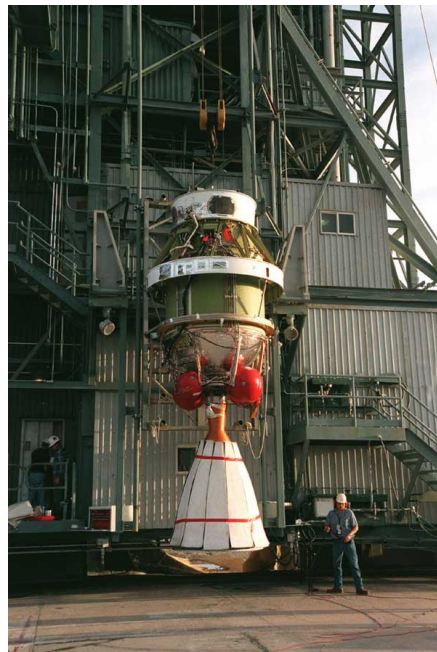
**Non-operational Spacecraft**

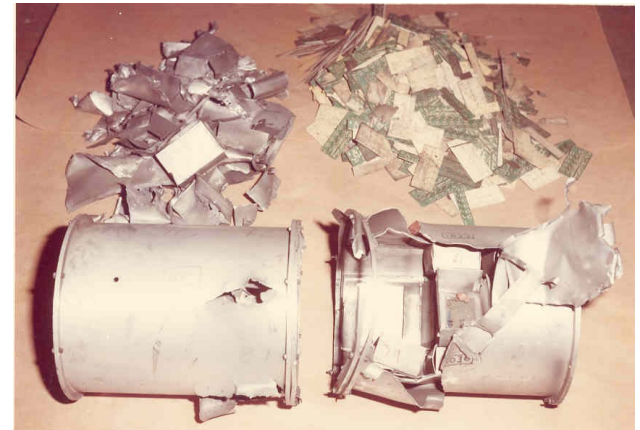
**Derelict Launch Vehicle Stages**

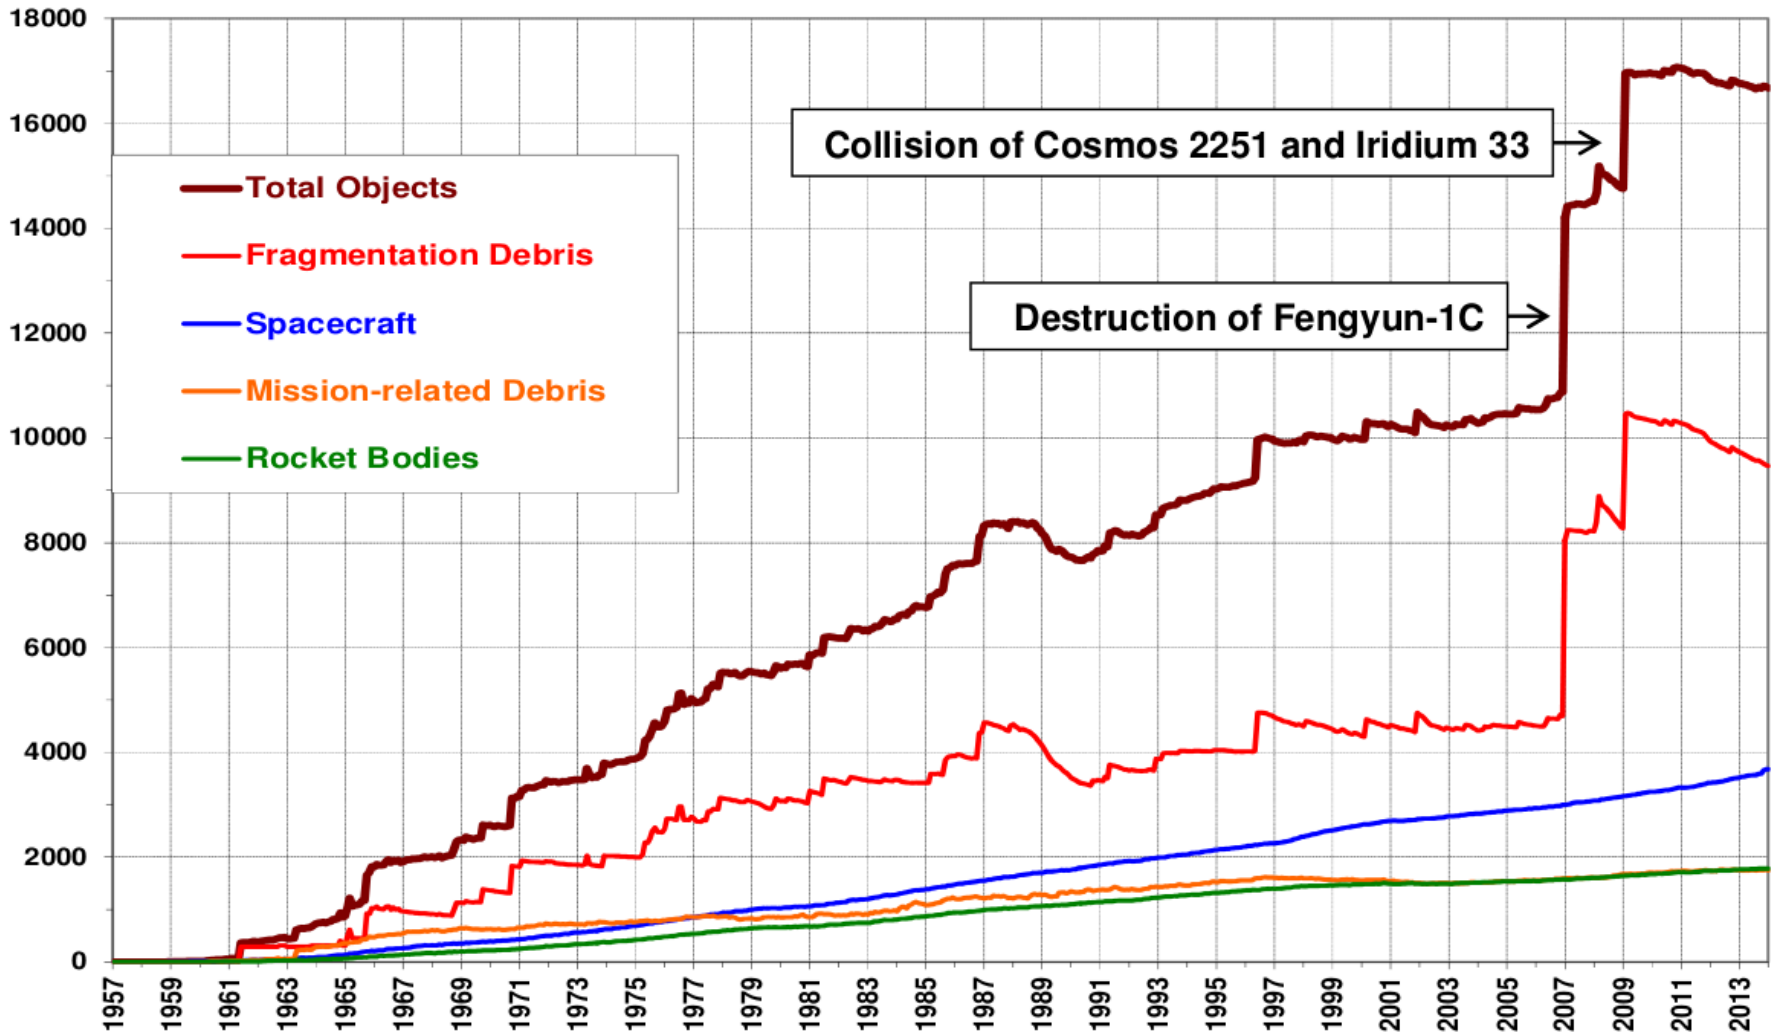
Number of Cataloged Objects in Earth Orbit

# Evolution of the Cataloged Satellite Population

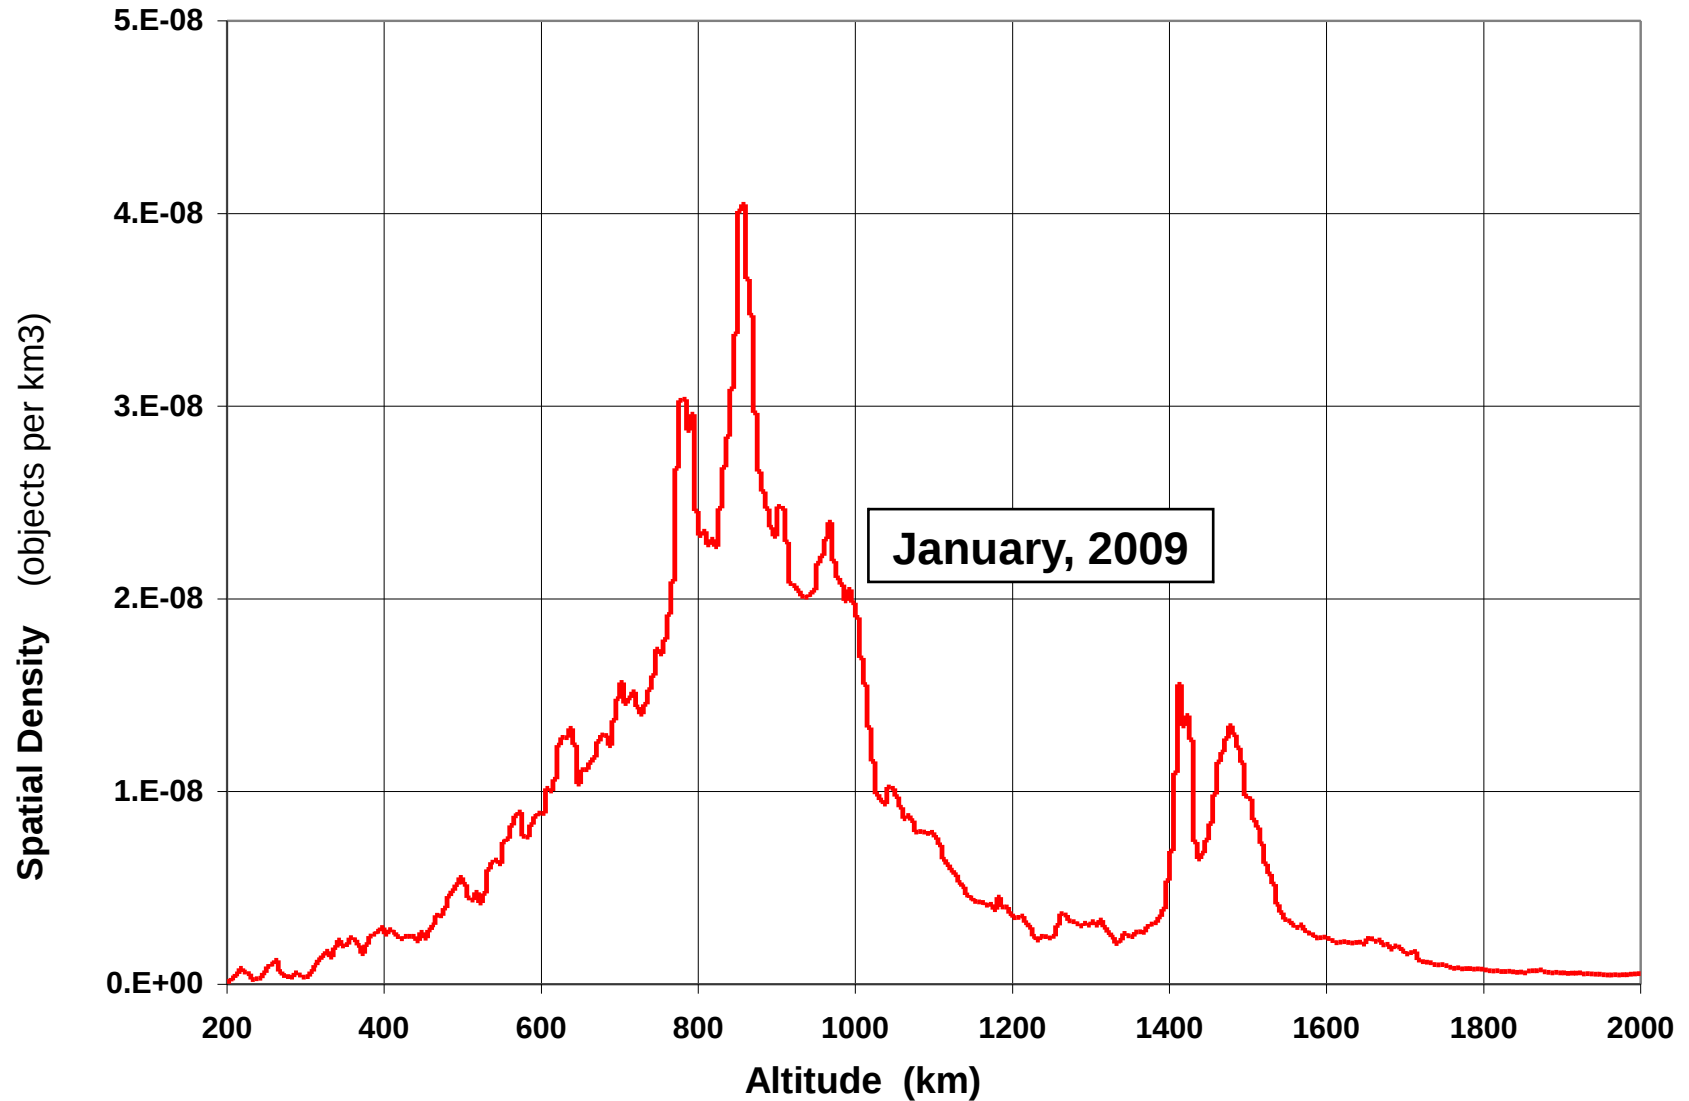
# Altitude Distribution of Debris

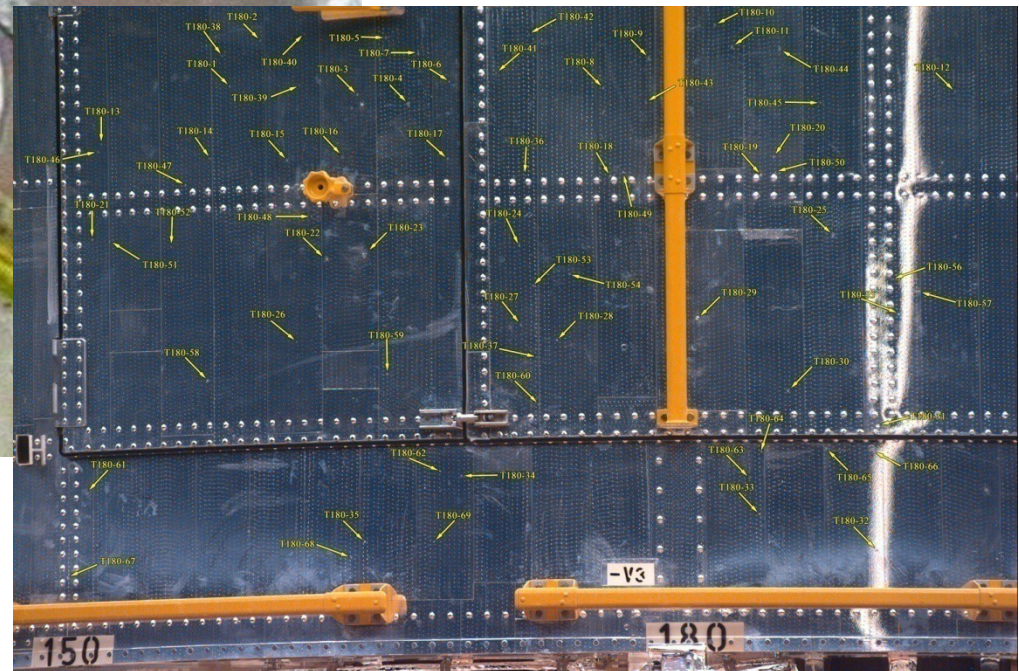
After 7 years in space the Hubble Space Telescope had been peppered with more than 500 craters on its aft shroud

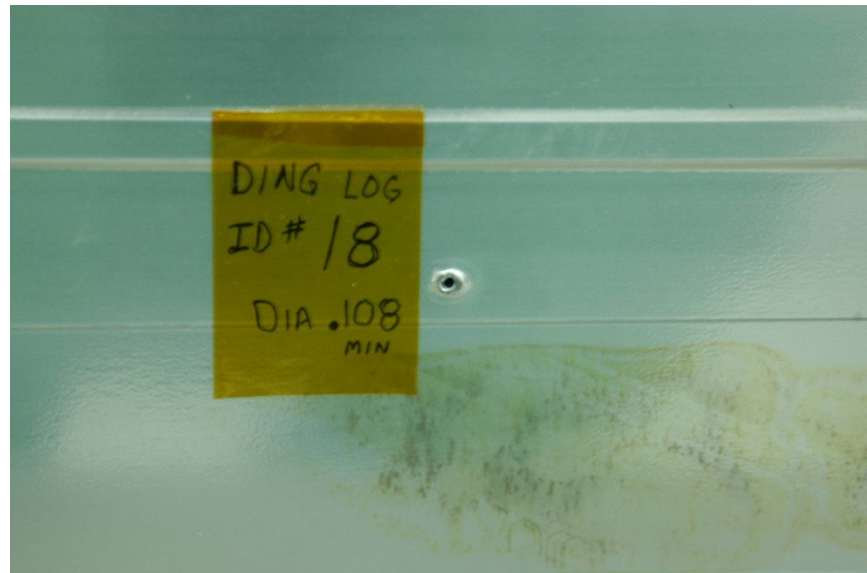
- The debris punched all the way through the radiator.
- The face sheet hole was 2.8 mm in diameter.
- The core inside the panel was completely destroyed for at least a 2.5 cm diameter below the face sheet damage.
- Impactor was determined from chemical analysis of residue to be orbital debris

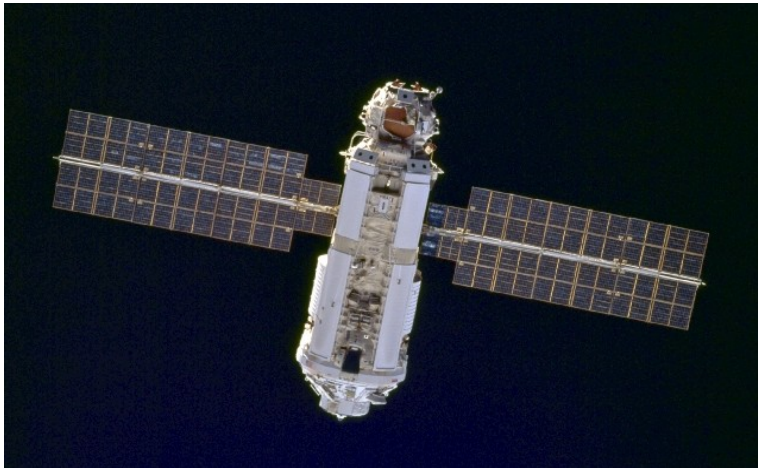
November, 1998

- After more than 15 years the ISS has grown from a single 20 metric ton module to a complex laboratory with a span of nearly 100 meters and a mass of almost 500 metric tons.
- Despite being the most heavily shielded vehicle ever flown in space, some portions of ISS are vulnerable to space debris particles as small as 3 mm in size, and all critical modules and components are vulnerable to space debris 1 cm and larger.

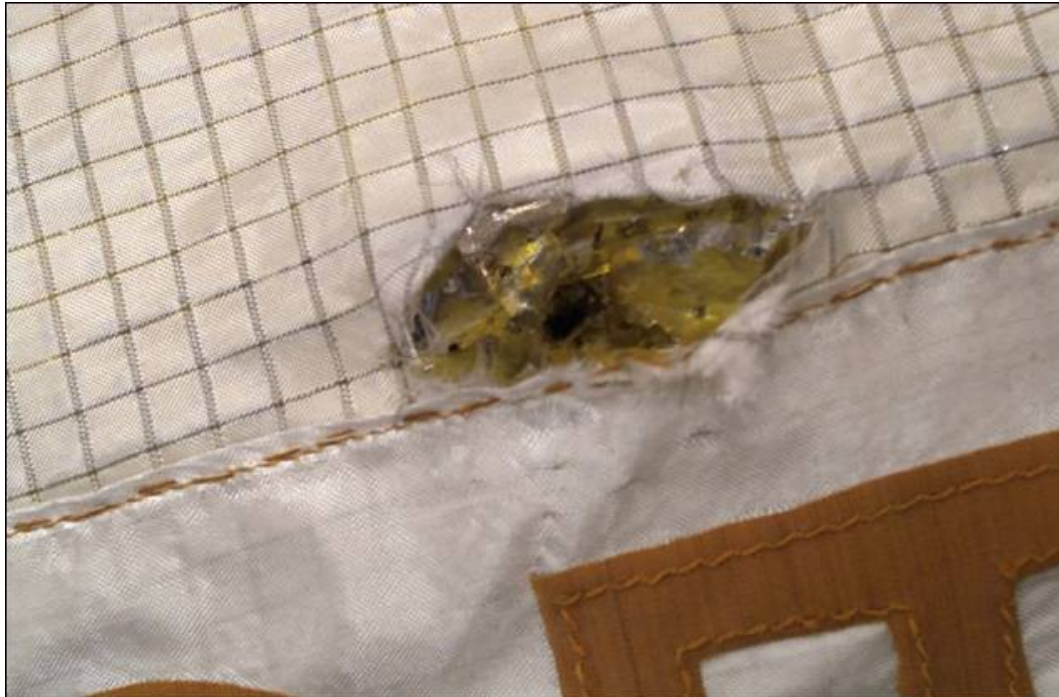
- The Zarya module was the site of one of the largest space debris impacts on the ISS main structure.
- The particle, estimated to be 2-3 mm in diameter, penetrated the module's thermal blanket and the underlying steel mesh, fiberglass, and aluminum honeycomb layers, but did not damage the compressor immediately below.

Tear, 6.7 cm long and 3.3 cm wide, was discovered in 2007.

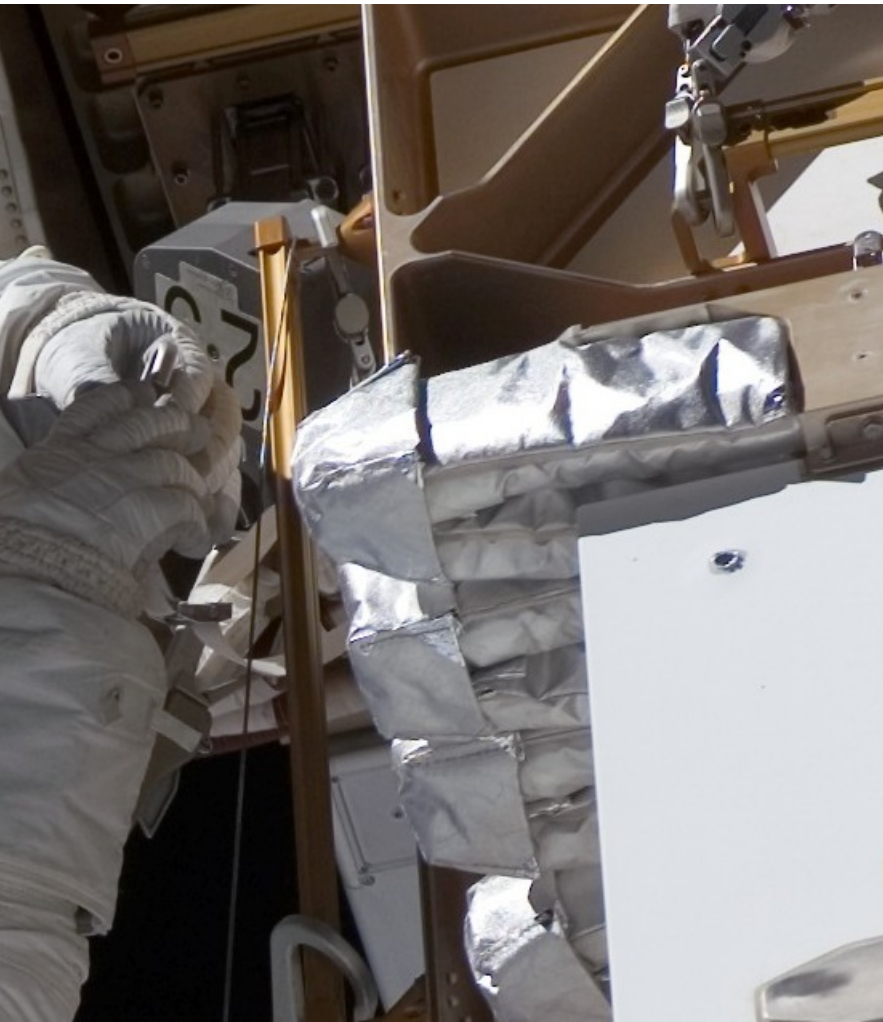
S118E06313

- Also in 2007, a crew member on EVA noticed a hypervelocity impact crater while working near a large aluminum panel.

Space debris  
impact site

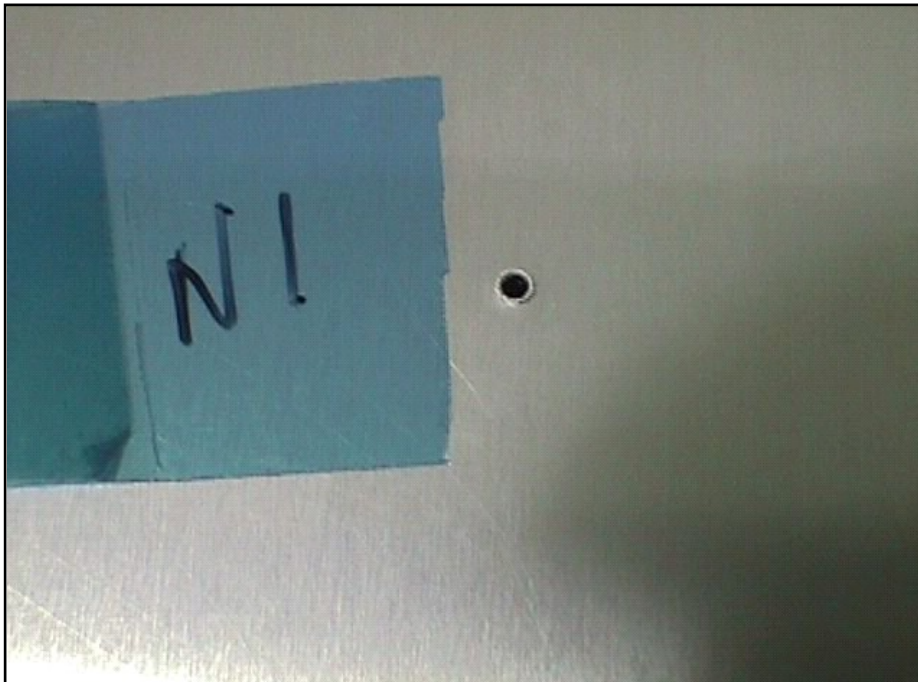
- Although rarely are components of the ISS returned to Earth, the large Multi-Purpose Logistics Modules (MPLM's), which occasionally ferry equipment to and from the ISS, offer just such an opportunity.
- By the end of 2008, a total of eight MPLM missions had been conducted, and nearly 200 instances of space debris impacts had been identified.

**Hole found in the space debris shield after the first flight of an MPLM to the ISS in 2001.**

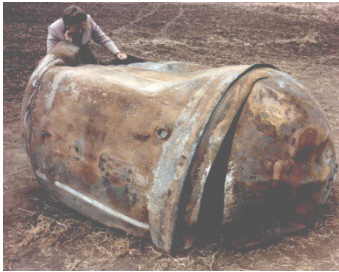
**Texas, 1997**

- **ORSAT (Object Reentry Survival Analysis Tool) is a high-fidelity model to predict reentering satellite behavior and to aid in determining casualty risks to the world population.**

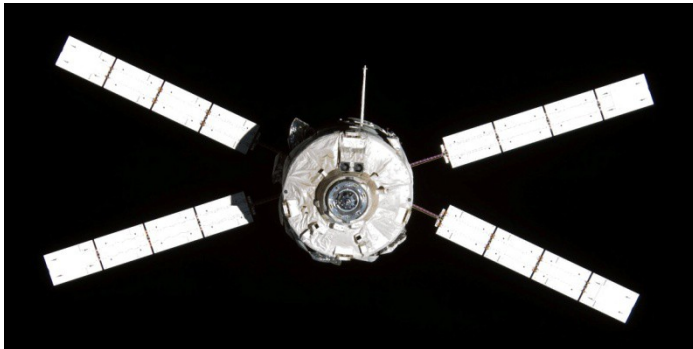
**Jules Verne undocking on  
5 September 2008**

- **NASA and ESA conducted a joint observation campaign of the reentry of the Jules Verne ATV on 29 September 2008.**
  - Two aircraft collected a wide variety of data from vantage points over the Pacific Ocean near the reentry path of the Jules Verne.

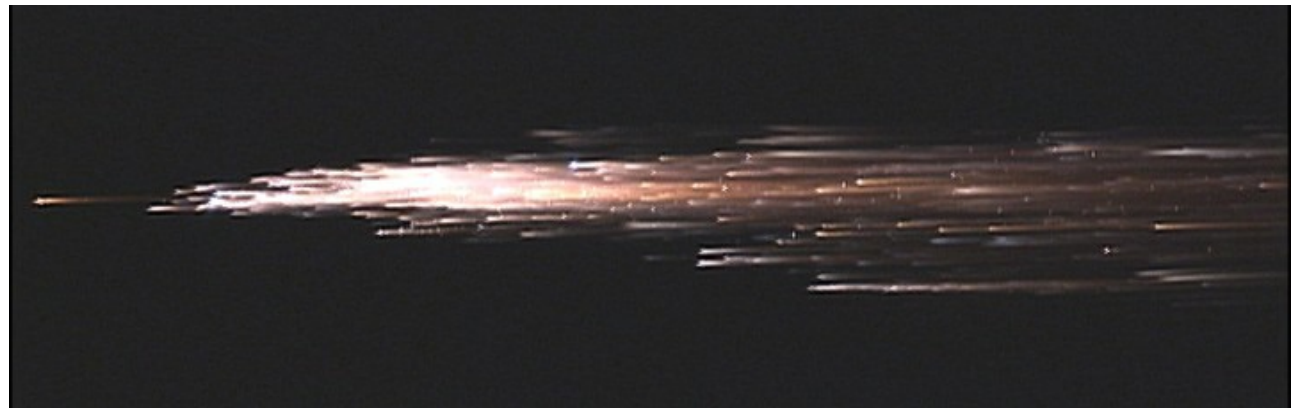
**Reentry over  
Pacific Ocean**
